Possible Soil Removal Report

Analysis of Tower 30 & 32 Site

For:
PG&E

Final Revision 0
March 03, 2017

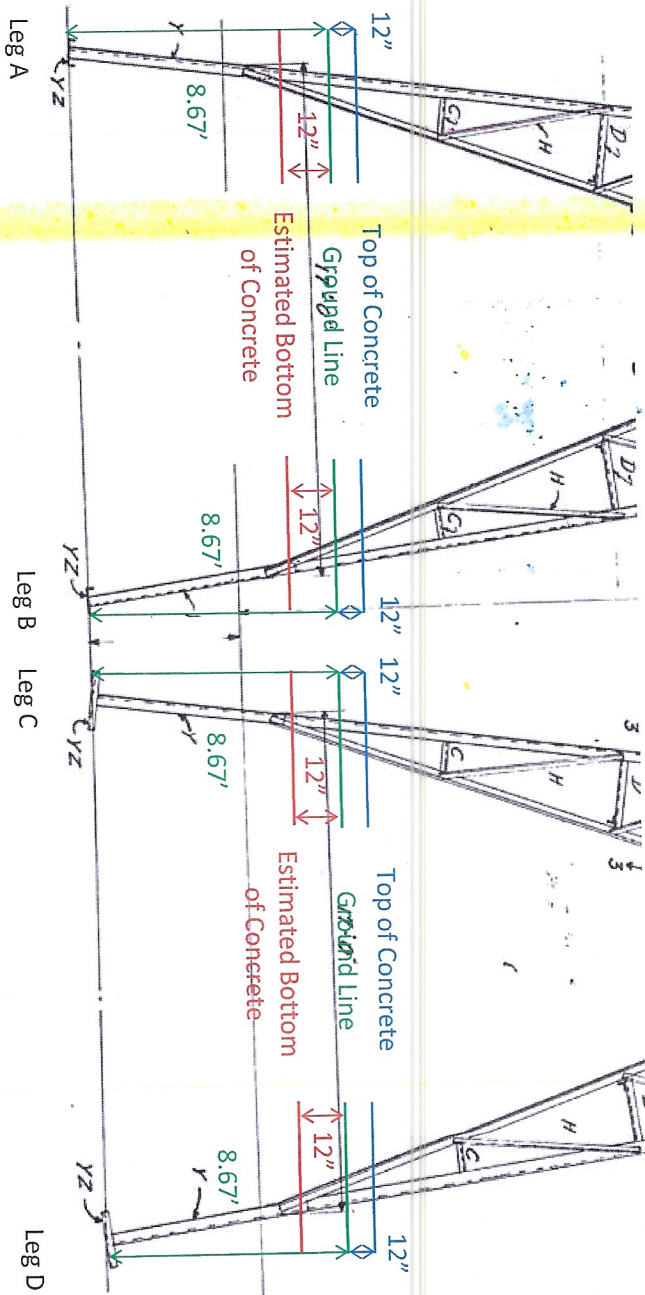
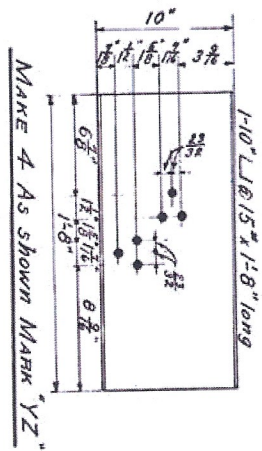
Tower 30 – Profile View of Foundation

- Notes:
- Values shown on this page are estimates based on photos taken with no measurements.
 - Concrete is a cap only and does not extend to the bottom of the foundation.

- Maximum uplift loads for the intact loading case is 6,840 lb with 1.5 OLF and 4,560 lb with 1.0 OLF.
- Maximum uplift loads for the broken wire case (2 conductors broken) is 12,850 lb with 1.0 OLF.
- Pictures indicate that the top two conductors have been raised and arms have been retrofitted to hold post insulators. This retrofit has increased foundation loads from the original conditions.

It is the opinion of ASEC that no ground disturbance should occur inside of a 13' radius of the point where the tower leg intersects with the ground unless an engineered solution is obtained for that ground disturbance.

The depth of the concrete cap may vary from what is shown in this report. Do not excavate below the bottom of the concrete cap unless an engineered solution is obtained for that excavation.

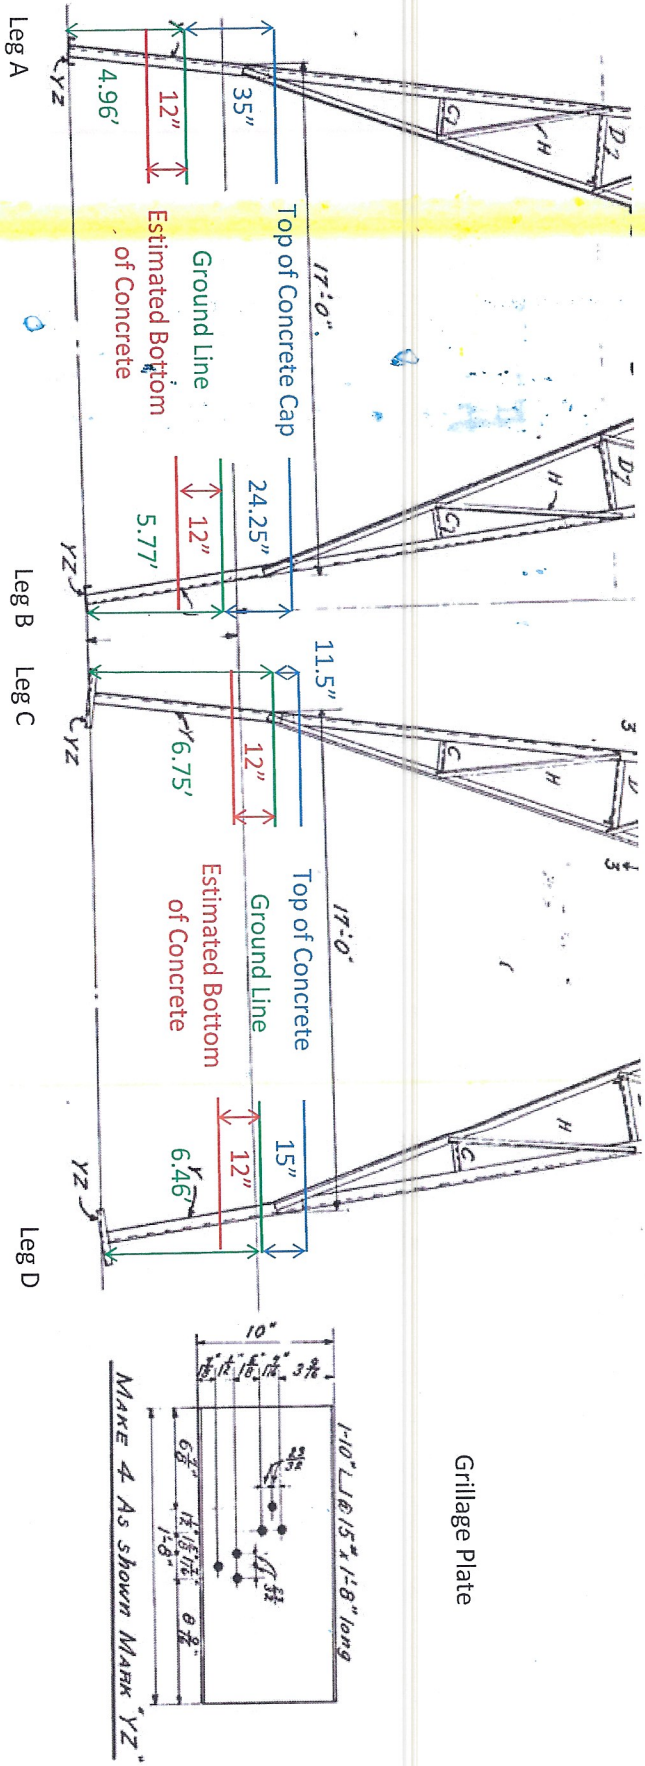
Tower 32 – Profile View of Foundation

- Notes:
- Values shown on this page are averages of measurements taken in the field.
 - Concrete is a cap only and does not extend to the bottom of the foundation.

- Maximum uplift loads for the intact loading case is 5,160 lb with 1.5 OLF and 3,440 lb with 1.0 OLF.
- Maximum uplift loads for the broken wire case (2 conductors broken) is 7,450 lb with 1.0 OLF.
