Possible Soil Removal Report

Analysis of Tower 30 & 32 Site

For:
PG&E

Final Revision 0
March 03, 2017

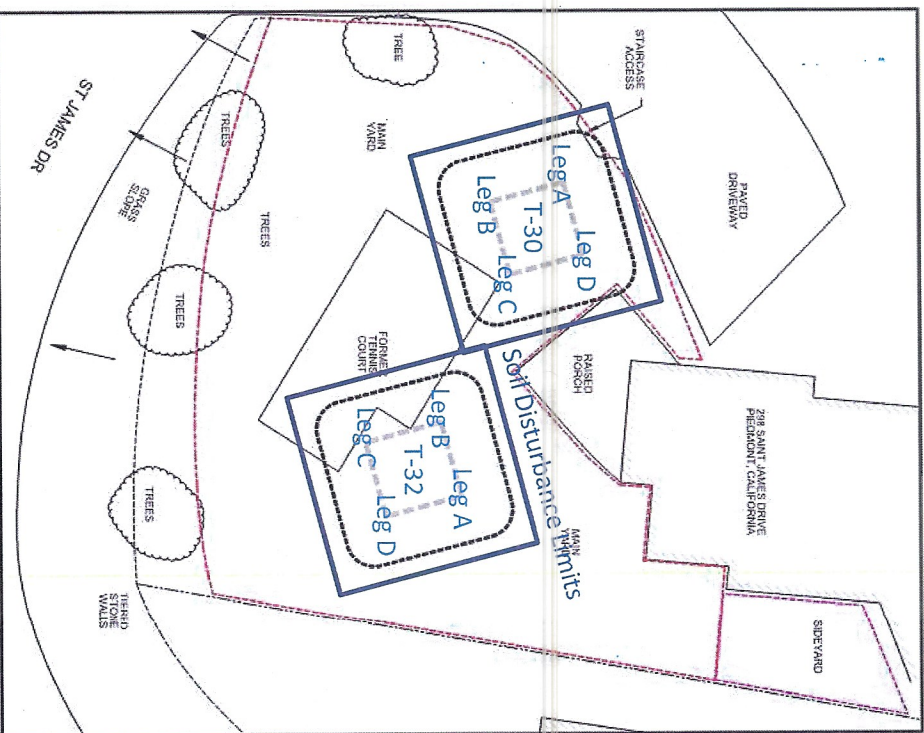
Plan View of Site

- The plan view of the site (page 4) shows the limits of future soil disturbance.
 - The profile views of the tower foundations (pages 5 – 6) show foundation depth information.
